No. 318: Beattys Bridge

Address	Beattys Road, crossing of Kororoit Creek, Aintree
Significance	Local
Construction Dates	1891, 1917, circa 1930s
Period	-
Date Inspected	6 February 2018

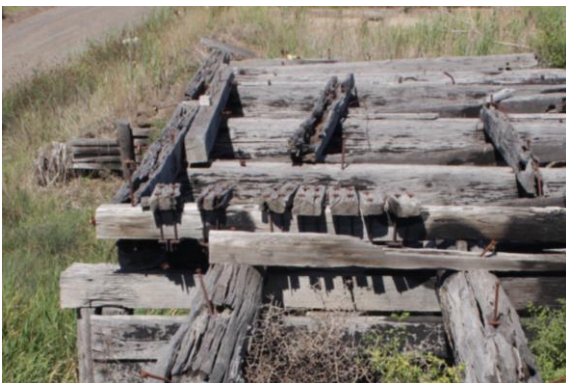
The 3 span timber road bridge extends about 21 metres across the creek and its deck is approximately 5 metres wide. The bridge is in poor condition and it appears that some sections have suffered fire damage. Many timber members are now missing including much of the deck and the full extent of the railings.

View of bridge from bank with remnant sections of longitudinal deck evident

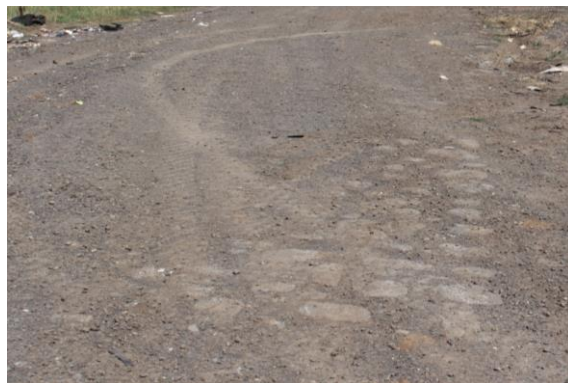
To the west of the bridge, remnants of stone cobbles are evident on the current alignment of Beattys Road where the gravel topping to the roadway has been worn/washed away. It is likely, that more of this stone is concealed nearby under the gravel finish.

Cobbles to Beattys Road, immediately to the west of Beattys Bridge
