Site Assessment – Parks and Reserves (City of Melton)

Park/Reserve Name:	Norm Raven Reserve	
Address:	Glitter Road, Diggers Rest	
Ward: -	Watts	
Melways Ref:	Map 352 B5	
Classification (Hierarchy):	Neighbourhood Reserve (IAMS), Neighbourhood Reserve (Draft OSS)	
Asset No (IAMS):	1339 (Reserve) and 5502 (Playground)	
Site Area:	1.1 hectares.	
Age:	26 years, 6 months	
Master Plan: Yes/No. If yes, state name and year adopted	No	
Date of Assessment:	3 June 2013

Park/Reserve Name:	Punjel Drive Reserve	
Address:	Punjel Drive, Diggers Rest	
Ward: -	Watts	
Melways Ref:	Map 52 C5	
Classification (Hierarchy):	Local Reserve (IAMS), Local Open Space (Draft OSS)	
Asset No (IAMS):	1441(Reserve) and 46427 (Playground)	
Site Area:	0.96 hectares	
Age:	18 years, 3 months	
Master Plan: Yes/No. If yes, state name and year adopted	No	
Date of Assessment:	3 June 2013

Park/Reserve Name:	Diggers Rest Recreation Reserve	
Address:	Plumpton Road, Diggers Rest	
Ward: -	Watts	
Melways Ref:	Map 352 A4	
Classification (Hierarchy):	District Reserve (IAMS), District (Draft OSS)	
Asset No (IAMS):	719 (Reserve) and 5501 (Play space)	
Site Area:	8 hectares	
Age:	22 years, 10 months	
Master Plan: Yes/No. If yes, st

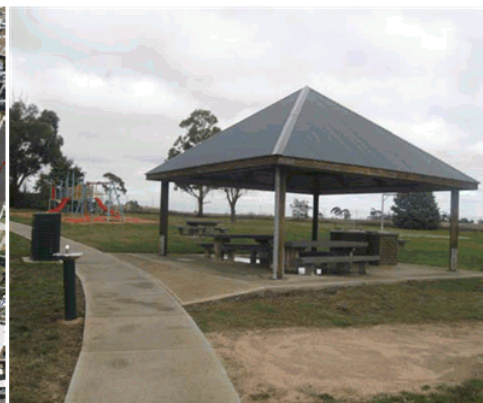
Park/Reserve Photo

- Irregular shaped reserve that is flat (slight fall from north to south) and contains a rotunda/shelter (timber posts and colourbond roof) with picnic tables and a BBQ. Additional picnic tables located to the south and west of the rotunda/shelter. Waste bin and drinking fountain located to the east of the rotunda/shelter.
- A play space area is located to the south of the rotunda/shelter
- Half court basketball area located to the west of the rotunda/shelter.
- A concrete path is located along the eastern side of the reserve and connects with a circular granitic sand path located within the reserve.
- Established landscaping (trees) planted within and around the perimeter of the reserve.

- The existing infrastructure and equipment in the reserve is generally in very good condition.
- Play space area only has minor damage to the swings but otherwise in good condition.
- Rotunda/shelter appears brand new while BBQ and picnic tables are in very good condition.
- Landscaping is in good condition.

- Large reserve that has been developed with a rotunda/shelter, BBQ, picnic tables, park bench seating, basketball court (half court), play space, drinking fountains, waste bins, paths and landscaping.
- All infrastructure identified as being recommended or desired under the draft OSS hierarchy has already been provided at this reserve except for bicycle racks.
- The reserve is greater than 15 years old, however, appears to have been developed more recently.
- There is space available on the northern side to upgrade/develop the reserve further to include a sports oval or playing field or include additional seating, drinking fountains and exercise/fitness stations around the existing granitic stand path.

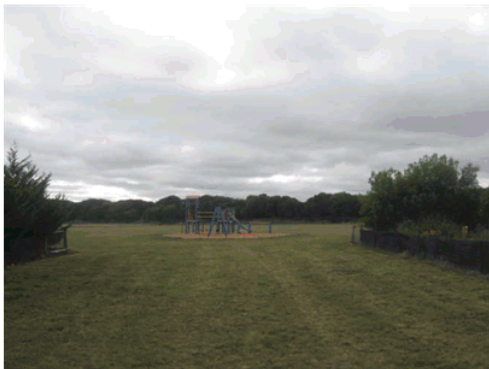
Park/Reserve Photo

- Battle-axe shaped reserve that is relatively flat and contains a small play space area in the centre of the reserve.
- Landscaping (trees) confined to the southern (front) portion of the reserve.
- Residential development to the north, south, east and west of the reserve. The north-east boundary of the reserve adjoins the Calder Freeway.
- A sign has been erected at the front of the reserve advising that no trail bikes are allowed on the reserve.
- Timber bollards/posts erected along the southern boundary of the reserve to prevent vehicle access.
- A 15.3 metre wide carriageway easement is located along the western boundary of the reserve.

- The reserve is well maintained and the play space area is in good condition.
- Landscaping planted at the southern end of the reserve is in fair to good condition.

- The reserve is mostly undeveloped except for a small play space area. It has an awkward shape with a narrow entry from Punjel Drive and the northern portion of the reserve partially hidden from the road.

- All infrastructure recommended or desired under Council's draft OSS has been provided as part of this reserve except for drinking fountains, paths, picnic tables, seating, signage and waste bins

- The reserve is more than 15 years old and could be upgraded or development to accommodate this infrastructure due to its proximity to public transport and the lack of any other similar open space areas within walking distance.

- However, it is constrained by its awkward shape, lack of surveillance, difficulties in terms of access, carriageway easement along the western boundary and lack of any link with any other open space reserve (linear or non linear).

- There is the potential to consider removing and relocating the playground equipment to Stan Payne Reserve which is located in the centre of the township (adjacent to the railway station) and selling the reserve given that it is zoned for residential purposes.

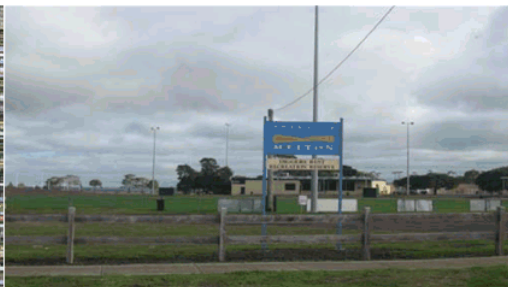
Park/Reserve Photo

- The reserve is rectangular in shape and relatively flat with frontage to Plumpton Road (east), Vineyard Road (west) and Houdini Drive (north).
- The reserve contains two sports ovals with sports ground lighting, coaches boxes, cricket wickets and irrigation. Two separate concrete pavilions with steel framed verandahs at the front located on the northern side of Oval 1. Scoreboard located on the left hand corner of the main pavilion. Park bench seats located between the oval and the pavilion.

- Overall, the reserve is in good condition with some works recently undertaken in accordance with the approved master plan – construction of a new netball court, shelter, picnic tables and play space area to the eastern side of the tennis courts and north of Oval No.1).
- Pavilions are generally in good condition particularly those adjacent to Oval No.1. The tennis club pavilion is in fair condition but looks in need of an upgrade/improvement. The scout hall is also in fair condition and has some graffiti on the front of the building.
- Cricket practice nets are brand new except for one practice wicket that looks old and is not covered by any netting.
- Sportsground lighting is in very good condition.
- Landscaping in good condition.
- Half court Basketball area and skate park are in good condition.

- Reserve is in the process of being developed in accordance with the master plan adopted by Council in 2007. A new netball court has been constructed adjacent to the tennis courts and a new shelter with picnic tables and play space is located adjacent to (eastern side) of the court. New scoreboard has been installed on the eastern side of Oval 1 and the orientation of Oval 2 has changed from north-south to east-west in accordance with the plan. A new mod grass tennis court has been constructed to the west of the existing courts and the practice cricket nets have been relocated to the west of the tennis courts.

- However, extensions to the sports pavilions and tennis clubhouse have not occurred at this stage and the proposed vehicle access and car parking arrangements from Houdini Drive (north), Plumpton Road (east) and Vineyard Road (west) have not been undertaken at this stage,

- In relation to the draft OSS hierarchy for district level reserves, all recommended and desired infrastructure has been provided except for BBQ's, bicycle racks, paths and water features. None of these are currently identified in the approved master plan.

- It is considered that a BBQ area with shelter and picnic tables could be accommodated (location to be determined) as part of the reserve and paths to link all facilities and car parking areas together and provide a space for people to walk, jog and cycle without using the existing ovals.
