**Site Assessment – Parks and Reserves (City of Melton)**

Park/Reserve Name:	Black Knight Way Reserve
Address:	Black Knight Way, Kurunjang
Ward: -	Coburn
Melways Ref:	Map 337 C2
Classification (Hierarchy):	Neighbourhood Reserve (IAMS), Neighbourhood Open Space (Draft OSS)
Asset No (IAMS):	419 (Reserve)
Site Area:	2.3 hectares
Age:	8 years, 7 months
Master Plan: Yes/No. If yes, state name and year adopted	No
Date of Assessment:	13 June 2013

Park/Reserve Name:	Little Blind Creek Linear Reserve (Rain Lover Drive)
Address:	Rain Lover Drive, Kurunjang
Ward: -	Coburn
Melways Ref:	Map 337 C3
Classification (Hierarchy):	Linear Reserve (IAMS), Waterways/Linear Parks and Trails (Draft OSS)
Asset No (IAMS):	47535 (Reserve)
Site Area:	10.8 hectares
Age:	Unknown
Master Plan: Yes/No. If yes, state name and year adopted	No
Date of Assessment:	17 June 2013

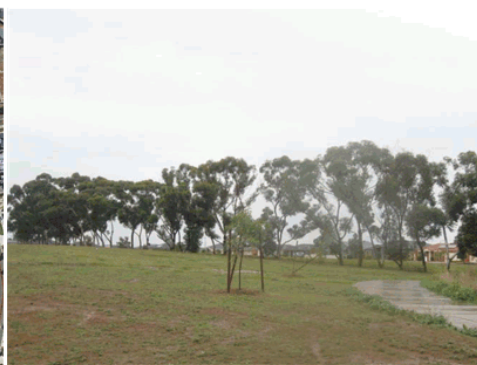
**Park/Reserve Photo**

- Larger, irregular shaped reserve that falls from the eastern (Black Knight Way) to the western boundary (Little Blind Creek).
- The reserve is undeveloped except for landscaping planted in the middle of the reserve and a small section of concrete path along the western boundary which connects with the path in the adjacent Little Blind Creek Linear Reserve.
- Some new landscaping planted at the southern end of the reserve adjacent to the concrete path.
- Reserve is bordered by local roads to the north, south and east and Little Blind Creek (west). Residential development fronts the reserve to the north, south and east.

- The reserve is in good condition in relation to the existing path (western boundary) and landscaping. Some landscaping at the western end of the reserve appears to have been only recently planted.

- The reserve is largely undeveloped with the exception of a small concrete path along the western boundary and landscaping.
- The reserve is currently classified as a Neighbourhood level reserve, however, does not currently contain any of the infrastructure recommended or desired for this type of reserve as outlined under Council's draft OSS.

- A master plan has not been prepared for this reserve. There is potential for a master plan or landscape plan to be prepared.
- The reserve is located adjacent to the Little Blind Creek Linear Reserve so there is the opportunity to develop the reserve in conjunction with this linear reserve and create a large active and passive open space for local residents and the broader community.

- The reserve is less than 10 years old, however, is undeveloped. Therefore, the development of the reserve should be considered as a medium-high priority to ensure local leisure and recreation needs are met.

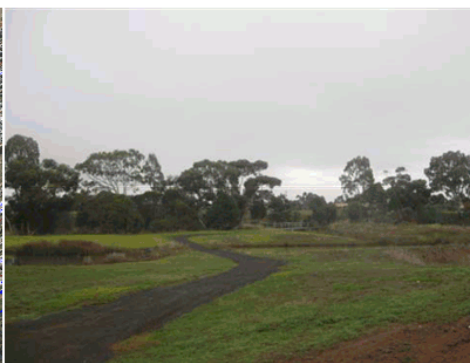
**Park/Reserve Photo**

- Linear reserve located along the southern side of Rain Lover Drive and The Embankment. The land slopes from the north to the south towards the creek. Little Blind Creek runs through the entire length of the reserve.
- No formal paths located within the reserve. An informal dirt path is located within the reserve adjacent to the northern boundary. However, a concrete footpath is located adjacent to the northern boundary of the reserve. A gravel path exists from Rain Lover Drive between two small wetland areas to a timber footbridge which crosses the creek.
- Landscaping planted with the reserve including the creek and wetland areas.

- The reserve is in good/fair condition. Informal dirt path is in poor condition, however, gravel path is in good condition.
- Landscaping also in good condition.

- Linear reserve that continues to the north and south and located on the northern side of Rain Lover Drive and The Embankment.
- Reserve is undeveloped due to constraints associated with the creek, wetlands and topography of the land.
- Opportunity to formalise existing dirt and gravel paths within the reserve and link them to the existing concrete paths to the north and existing footpath to east. Once the paths are constructed, the reserve could be developed further with park bench seating, drinking fountains, waste bins and exercise/fitness stations (if practical).
