Behlen Shed Statement of Significance

Heritage Place:	Behlen Shed <u>2-98 Staughton Street, Melton South</u> <u>Brooklyn Road, Melton South</u> <u>(on the railway reserve, part of 2-98 Staughton Street)</u>	PS ref no:	HO131
------------------------	-------------------------------------------------------------------------------------------------------------------------------------------------------------------	-------------------	-------

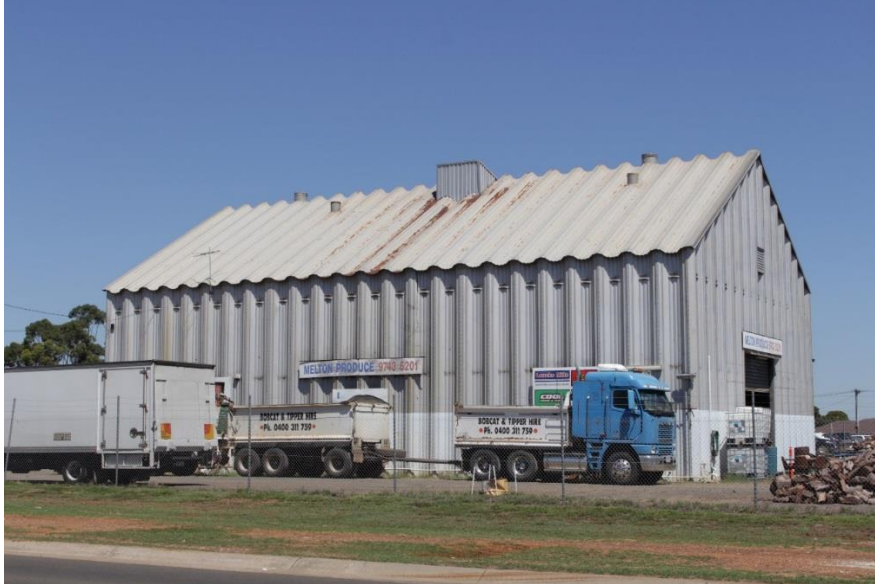
The Behlen Shed is a prefabricated frameless steel structure, originally used as a grain shed/silo, with a distinct profile that allows a clear open span internally. The location of the original distribution auger/elevator is evident to the north (road) side as is another chute on the south (track) side. The format of the shed is windowless with three doorways on the track side. After it ceased being employed for grain or chaff, a large doorway was introduced to both short elevations.

The Behlen Shed is aesthetically significant as an imported prefabricated structure utilising the frameless Dubl-Panl system developed by the Behlen Manufacturing Company of Nebraska, USA. It was one of probably only 13 employed by the Grain Elevators Board of Victoria. The structure is frameless, has a distinct undulating profile, consisting of a variety of secondary corrugations, etc. imprinted in the sheets, which provides its inherent strength. (Criterion E).
