Shire of Melton Dry Stone Walls Study

Volume 1 – The Report

Melton Dry Stone Walls Study

By Planning Collaborative (Vic) Pty Ltd

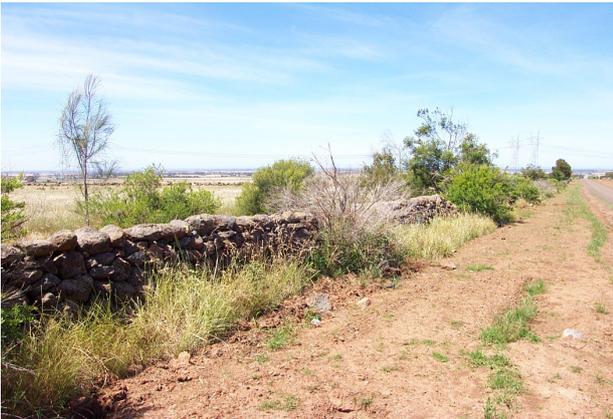
Wall F96 along Faulkners Road looking south from Mount Cottrell

Commission recommended against permanent fencing on road reserves.²⁰ At the same time, walls began to be built along the previously closed Faulkners Road, indicating that it was now open for traffic. One of these walls, built by Clarke, is today one of the best walls remaining in Melton Shire [Wall F96].

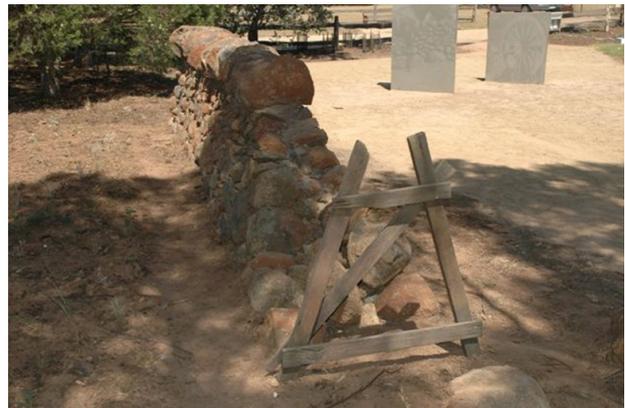
Figure 9: Volcanic Genesis

‘Volcanic Genesis’ was constructed in July 2006 by two of Victoria’s eminent dry stone wallers, David Long and Alistair Tune. The artwork includes a bronze A-frame which is modeled on the typical timber frames used by traditional wallers in the construction process and which would remain in place until each section of wall was completed. The A-frame was cast by renowned sculptor Bill Perrin of Melbourne and represents one of two A-frames which would normally be placed at either end of a wall to ensure it was constructed straight and true. The stones for the sculpture were sourced from farmland several kilometres west of Melton township.

The Sculpture Volcanic Genesis at ‘The Willows’ Historic Park is the work of wallers Alistair Tune and David Long and sculptor Bill Perrin. The rear of the signage that marks the start of the Dry Stone Walls Driving Trail can be seen the background of the photograph above. The drawing below is by the sculpture’s designer Jim Holdsworth. The plaque that commemorates the funding bodies, the installation of the sculpture, the artists and the designer is situated in the associated landscaping on a large rock adjacent to the sculpture.

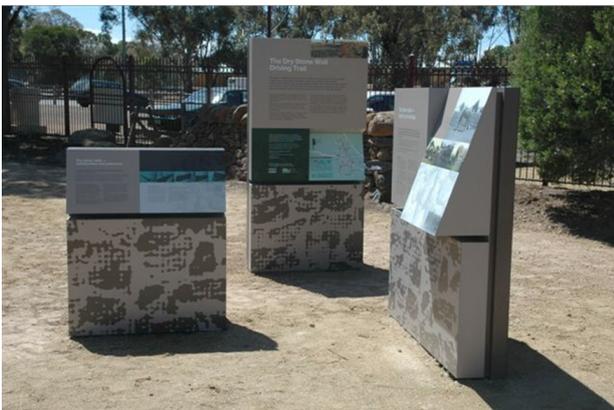
The photograph above shows the three Interpretative Panels that mark the starting point of the Driving Trail. The narrative includes a history of the Melton area and its dry stone walls' heritage, a map of the Driving Trail with information about the specific Areas of Interest and information about where to obtain the Driving Trail Brochure. They are sited in a prominent position at 'The Willows' close to the Sculpture 'Volcanic Genesis'.
