No. 318: Beattys Bridge

Address	Beattys Road, crossing of Kororoit Creek, Aintree
Significance	Local
Construction Dates	1891, 1917, circa 1930s
Period	-
Date Inspected	6 February 2018

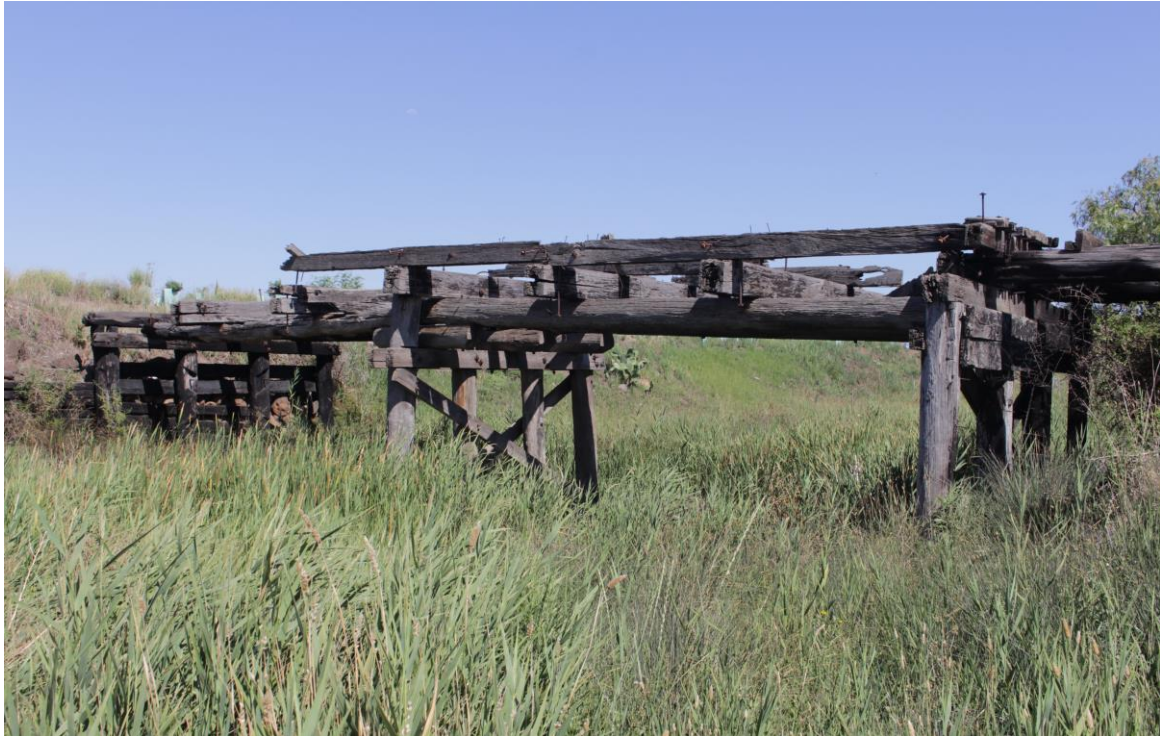
The 3 span timber road bridge extends about 21 metres across the creek and its deck is approximately 5 metres wide. The bridge is in poor condition and it appears that some sections have suffered fire damage. Many timber members are now missing including much of the deck and the full extent of the railings.
