Citation No. 7 - Selection Wall, Western Highway

Melton Dry Stone Walls Survey Nos:	Wall No N224. (The Gidney Wall)
Location:	2344-2412 Western Highway Rockbank; 1031-1085 Beattys Road Rockbank; 986-1008, 1010-1024, 1026-1040, 1042-1060 Leakes Road, Rockbank. Crown Allotments 2, 3, 5, Section 7, Parish of Kororoit
Critical Dates:	Original construction 1867-68; progressive (non skilled) repair and reconstruction
Existing Heritage Listings:	None
Recommended Level of Significance:	LOCAL

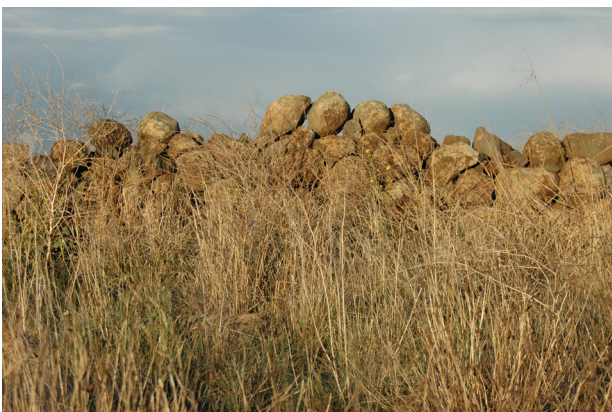
Wall N224.

A section of the southern part of the wall in typically variable condition. Its height is evident behind the tall grass impeding its view.

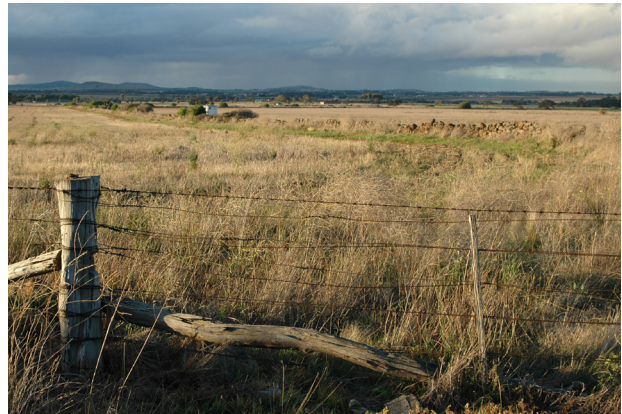
Wall N224.

Something of a sense of the length of the wall (in the middle distance) is evident from the the Western Highway at its southern end. The bushes (probably self-sown) help trace its form.

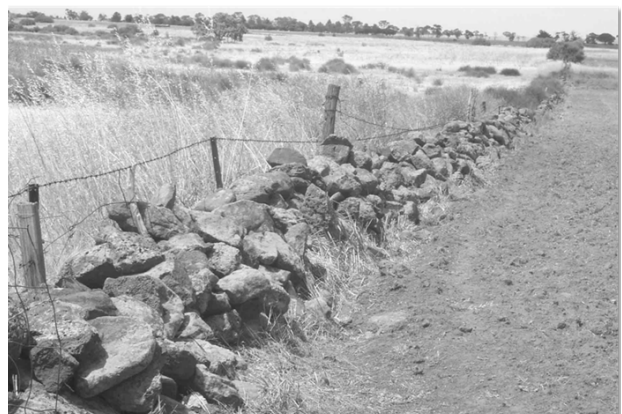
Wall N224.

The northern (Beattys Road) end of the wall has been topped up with a post and wire fence inserted into one side, and the wall itself has evidently been inexpertly topped up in the past. The dense rocks with which the wall was built can also be seen here;(these round stones are more evident in the photograph on the title page of this report).
